# Manhole Inspection Summary

Manhole # S29I\_\_045MH

Insp Date: **5/20/09 12:35 AM**

**Location** Address: **918 W Lombard St**

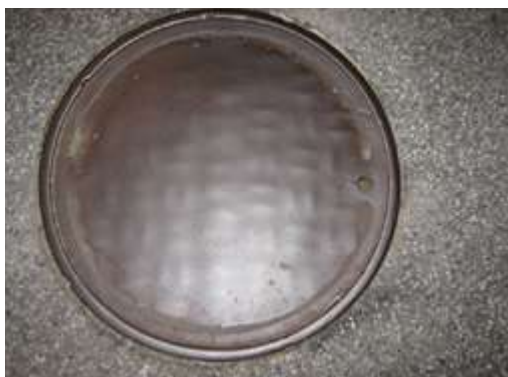
Miscellaneous

Type: **Sanitary** Condition: **Worn** Cover Material: **Cast Iron**

worn mh cover

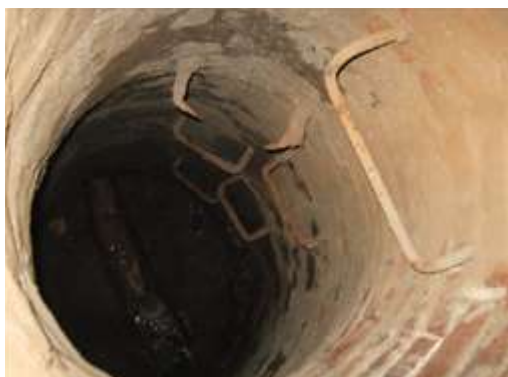
Defect 5

**Steps** Count: **6** Missing: **1** ☒ Corroded

corroded & missing rungs

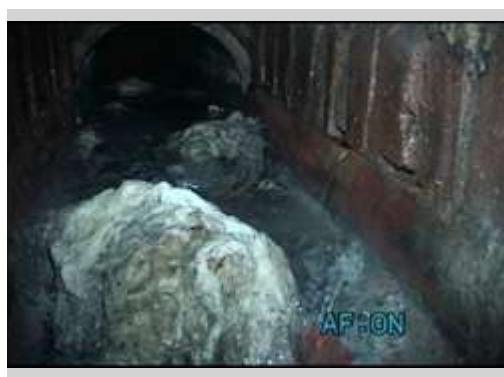
Defect 1

Condition: ☐ Sound ☐ Cracked ☐ Root Intrusion ☐ Deteriorated ☐ Leaks ☒ Debris

debris in channel

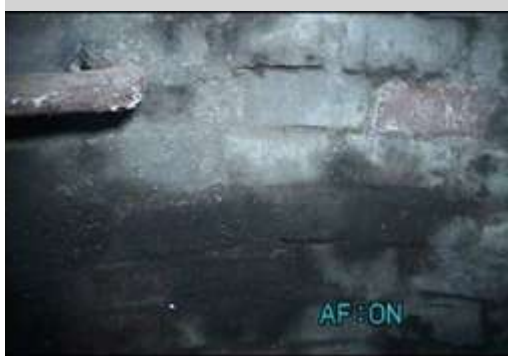
Defect 3

Infiltration: ☐ None ☐ Joint ☐ Cracks ☒ Mortar ☐ Roots ☒ Wall

seepage at corbel mortar/wall

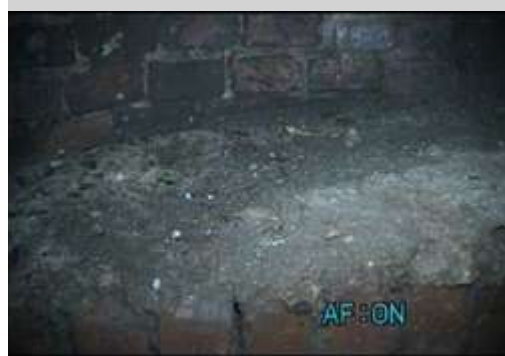
Defect 2

Condition: ☐ Sound ☐ Cracked ☐ Root Intrusion ☐ Deteriorated ☐ Leaks ☒ Debris

sediment on bench

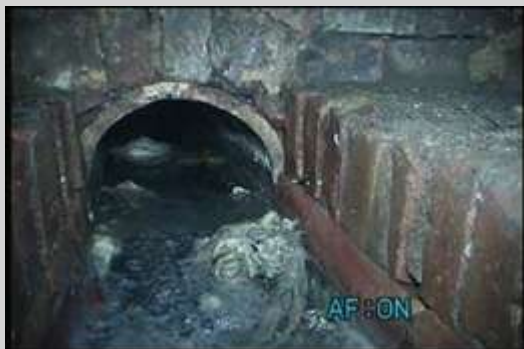
5 O'Clock Inflow

Pipe Height: **8.4** (in.) Rod and Bar (Angled)  
Pipe Material: **Clay** ☐ Pipe Lined  
Invert Depth: **11.02** (ft.) Flow Characteristics: **Fast**  
Deposits: ☐ None ☐ Mud ☐ Sludge ☒ **Debris** ☐ Grease  
Silt Depth: **0** (in.) Deposits Extent: **Light**  
Infiltration: **None** Pipe Seal Cond: **Sound**
